# Planning Policy Guidance 9

Ministry of Housing and Lands

28 March 2016

#### Development on Sloping Sites and Landslide Hazard Areas

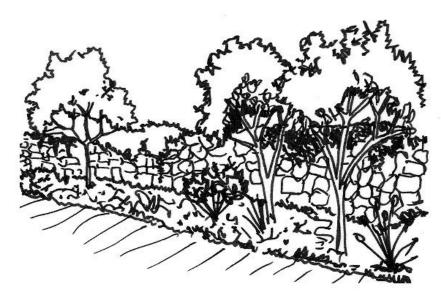
Landscaping in front of retaining wall

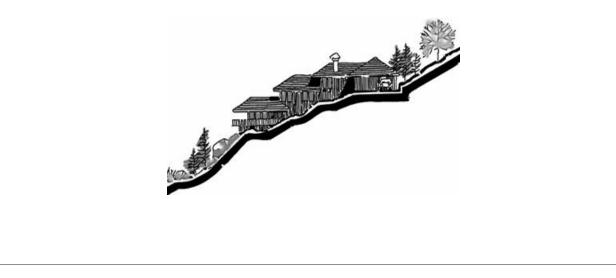
• Contrasting and varied horizontal and vertical building planes should be used to create various shades, and shadow patterns to reduce perceived bulk. Large expanses of wall in a single plane on downhill elevations should be avoided.
